1403-1407 MAIN STREET POLLOCK'S HARDWARE

City of Winnipeg Historical Buildings & Resources Committee Researcher: M. Peterson June 2022

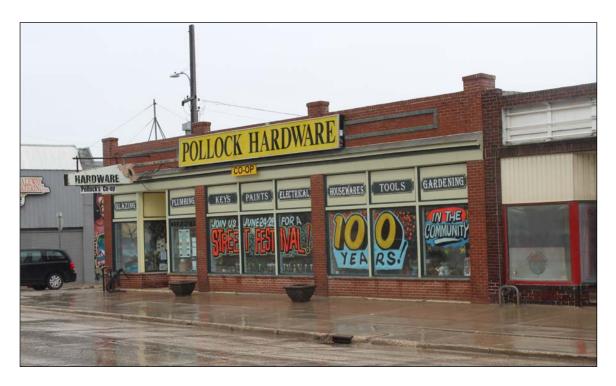
Plate 5 – Pollock's Hardware Store, 1403-1407 Main Street, front (west) façade, 2022. (M. Peterson, 2022.)

At present, the exterior has seen some alteration, specifically the replacement of the middle and south recessed entrances with display windows (Plate 5). It is unknown whether the glass block in the original plans was executed in the completed construction, but the space is occupied by signage. The south façade is covered by the neighbouring building and the north façade is uninterrupted except for the west end (Plate 6), although it appears a window has been bricked in at the east end of the elevation. The rear façade includes a lean-to (Plate 7).
